# SHRAPNEL PROTECTION TESTING IN SUPPORT OF THE PROPOSED SITE 300 CONTAINED FIRING FACILITY

Lawrence Livermore National Laboratory University of California, Livermore, California 94550

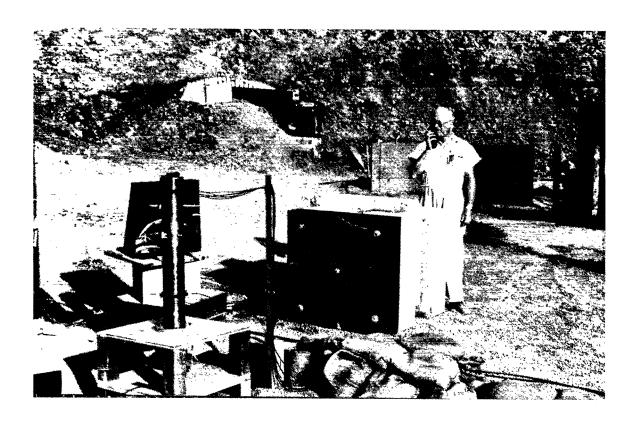
Figure 4. Test setup for a typical 4-in.cylinder shot with shrapnel protection test block in place (Test No. 4).

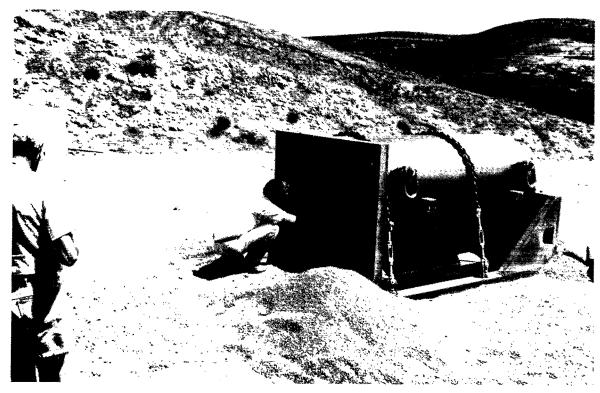
Figure 12. Physicist inspecting damage to the shrapnel protection plate for the gamma ray camera (Test No. 9).

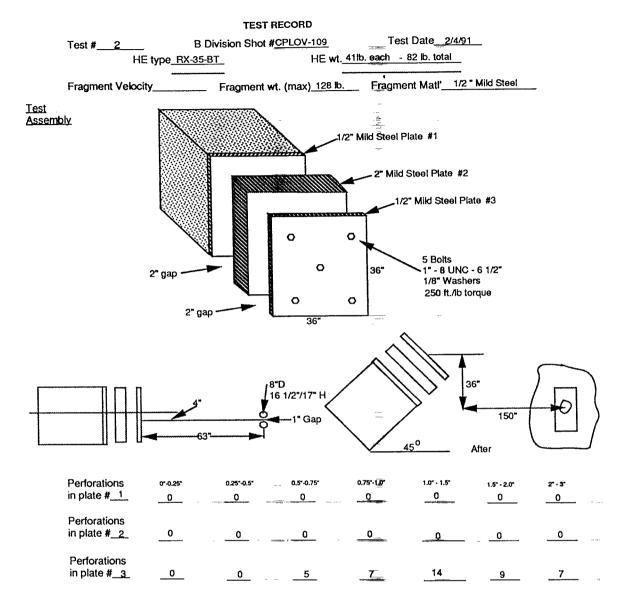
Test Record No. 1

Numerous pits in plate #2, five perforations of plate #2. Because of a single perforation of plate #1, the geometry is unacceptable.

Plate #1 - Impacts at edges. Bent plate at corners where concrete broke.

Plate #2 - No perforations. One stand-off loose. Major impacts up to 11/2" deep. Thirty impacts. Two-in. bend on edge of plate caused by blast.

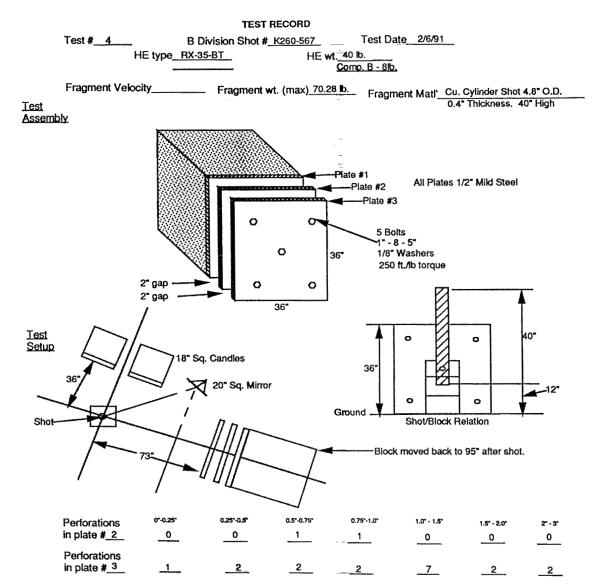
Numerous pits in plate #3, one perforation of plate #3.

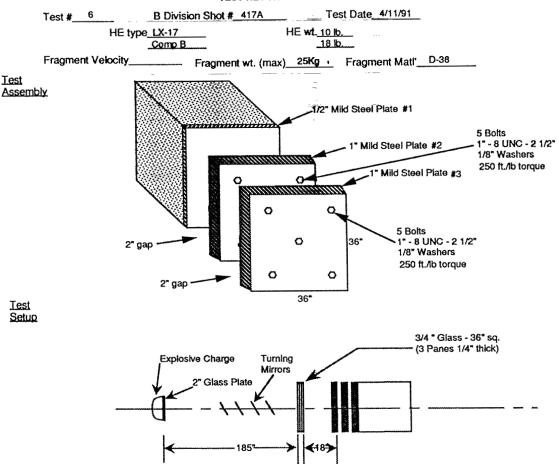
- Large dent in plate #3 as if hit by a projectile approximately 1" in diameter. Dent is approximately 1 1/4 " deep.
- Did not penetrate 1"-thick plate #3. Plate is deformed on back surface and does have a slight bend.
- · No damage to plates #1 or #2.
- Explosive charge was covered with 2" glass plate on surface face of hemisphere. Other turning mirrors may have also attenuated the impact.
- Since the test, we have learned that placing glass close to the explosive charge has a much greater effect on reducing the jet than placing the glass near the block assembly. Therefore, the effect of glass plates near the block assembly alone cannot be determined.
- The explosive charge generated a jet effect and did not produce shrapnel.
- In our experiment, the total effect of the glass (explosive charge face, turning mirrors, and plate glass) successfully protected our block assembly.

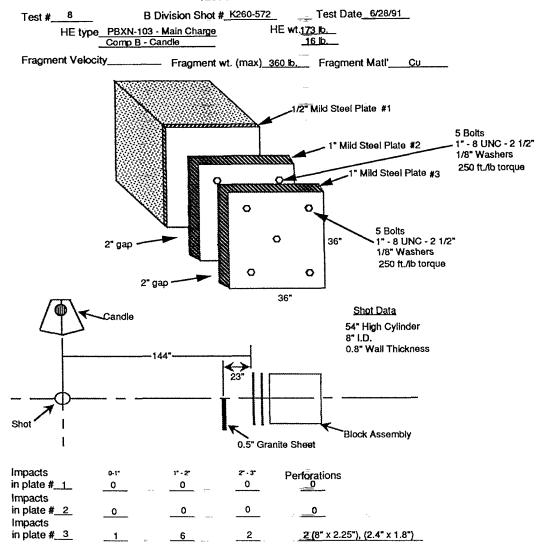
· No impacts on plate #1.

• Five impacts on plate #2. No perforations. Small dents to 1/8" deep, approximately 1/2" diameter.

• Major damage to plate #3. Slight bend in plate. Five perforations.

- Upper-right bolt head destroyed. Had to be removed with hammer, chisel, and channel lock pliers.
- Bolts holding plate #3 were at reduced torque. Damaged bolt was loose.
- . Bolts holding plate #2 were still tight but at approximately 200 ft./lb torque. They were retorqued to 250 ft./lb.

- · This was a very successful test. Plate #1 received no impacts.
- Plate #3 received impacts from Tests # 5, 6, and 7. It has now been replaced with a new plate.
